MARYLAND HISTORICAL TRUST  
NR-ELIGIBILITY REVIEW FORM

Property Name: Feaga-Albaugh Farmstead Inventory Number: F-3-226

Project: Proposed Cannon Bluff Subdivision Agency: Horizon Frederick II LLC

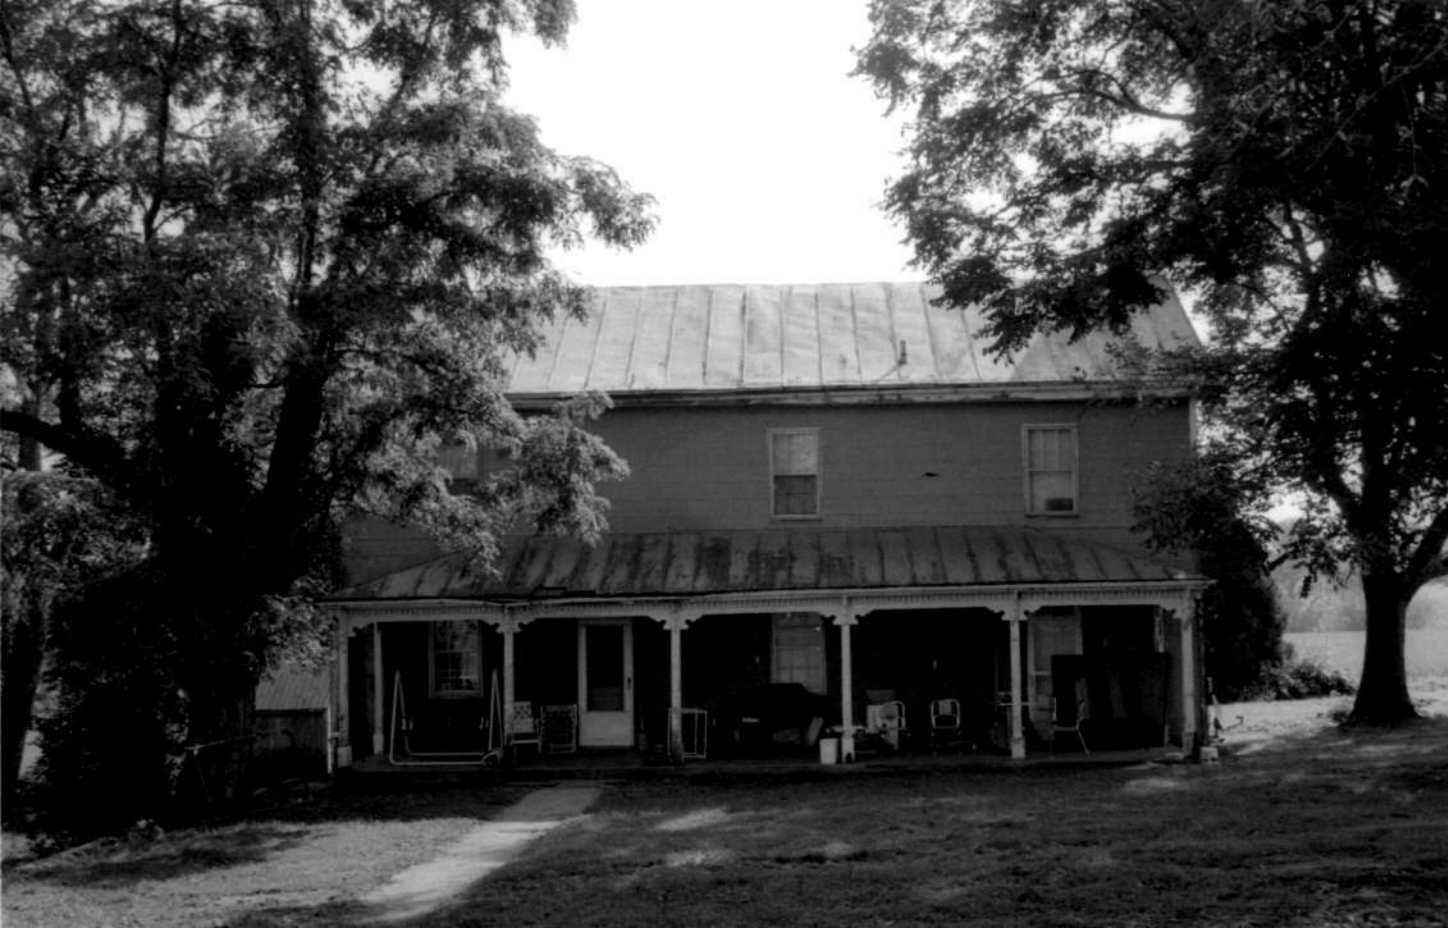
1/9

Farmhouse - front (west) elevation

*Exterior.* The main block rests on a stone foundation. The gable roof is sheathed in standing-seam metal and features gable returns and boxed eaves. An interior corbelled brick chimney rises on each gable end. Exterior walls are clad with asbestos shingles applied over wood siding. First- and second-story windows are wood-frame, six-over-six-light, double-hung sash units. Basement windows are metal-frame, two-light, fixed units.

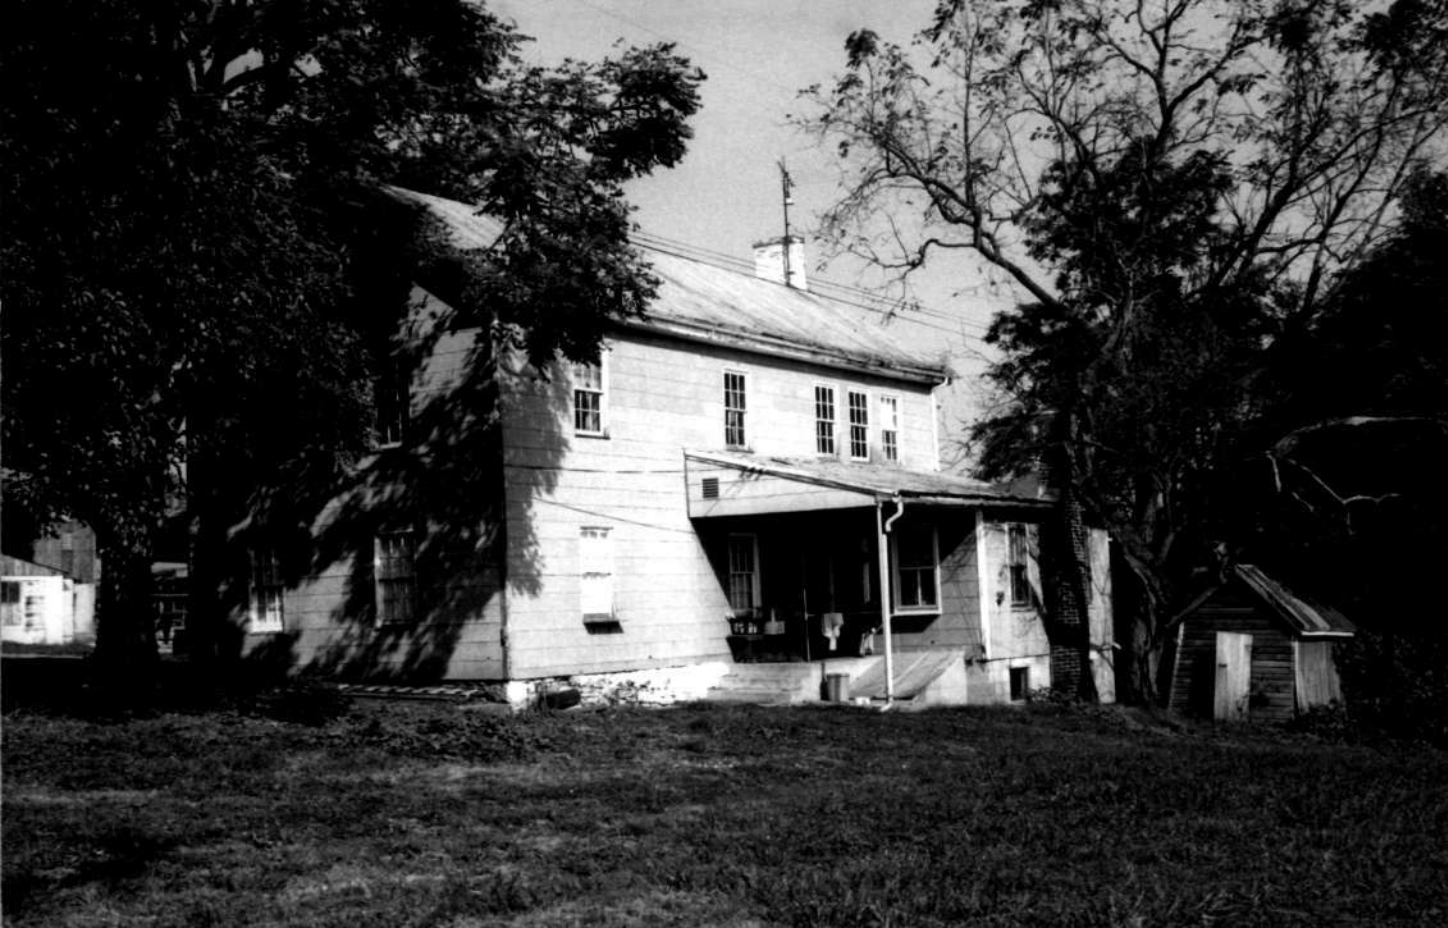
2/9

Farmhouse - SE corner; Small Shed - SE corner

A small shed, constructed in the early twentieth century, is located near the northeast corner of the house. The one-story shed faces south and features circular-sawn wood framing, a poured-concrete floor, and a front-facing gable roof sheathed in standing-seam metal. Exterior walls are clad with a combination of board-and-batten, vertical-plank, and drop-wood siding. A vertical-board door is located on the front (south) elevation. The shed is leaning to one side and is in poor condition.

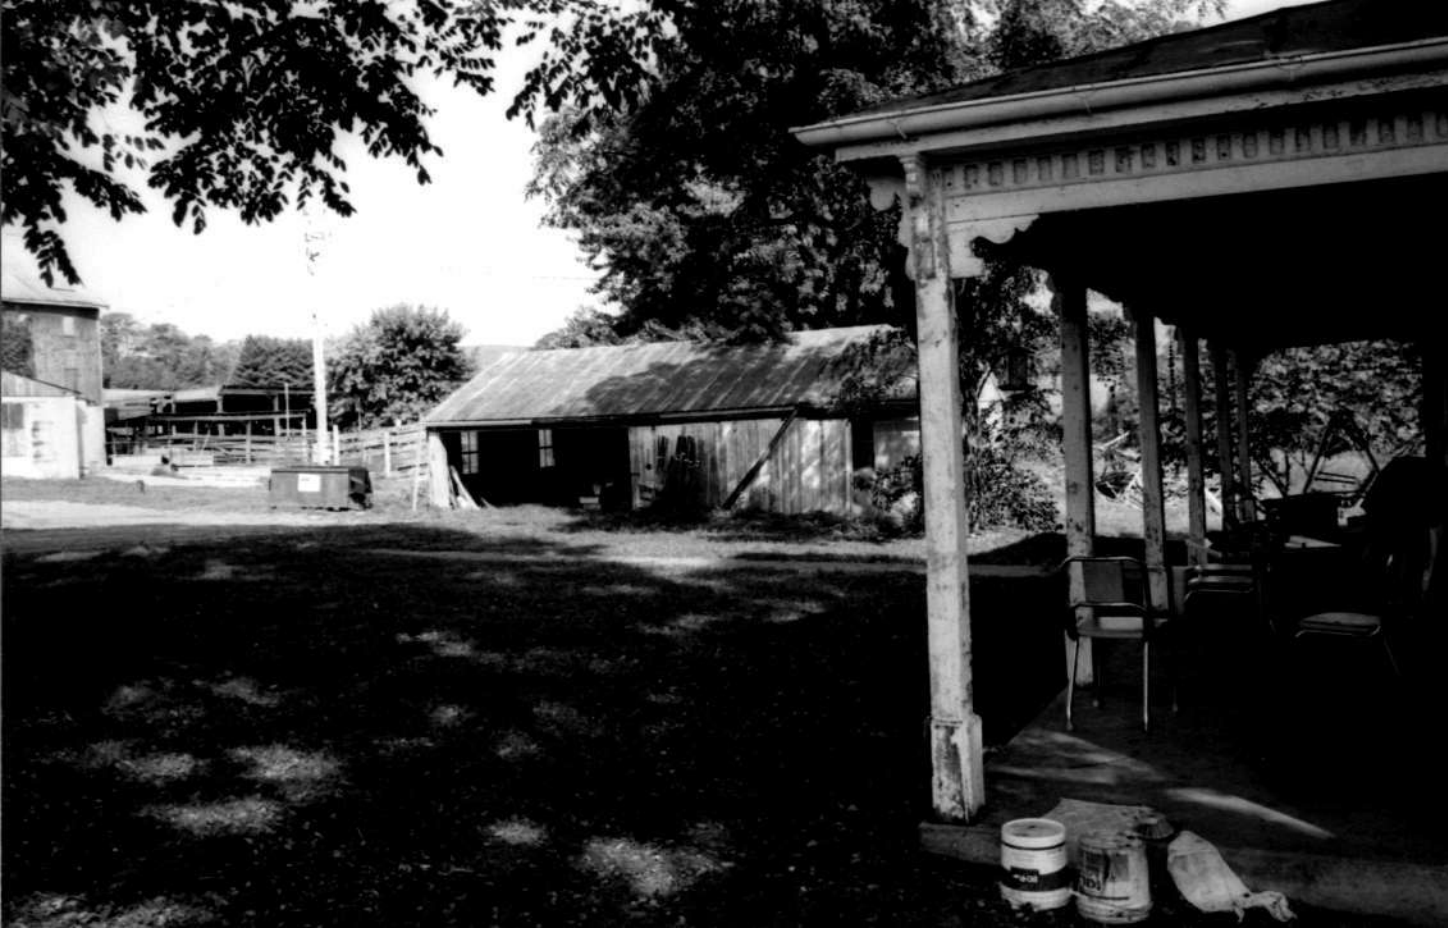
3/9

Farmhouse porch detail - S elev.; Garage - front (S)  
elevation

An early-to-mid twentieth century garage is located northwest of the house. The one-story garage faces south and is constructed of concrete block. The gable roof is sheathed in standing-seam metal and features boxed eaves. Gables are clad with vertical-board siding. A sliding-track, vertical-board door is located on the front (south) elevation. Windows are metal-frame, four-light, fixed-sash units. The garage is in fair condition.

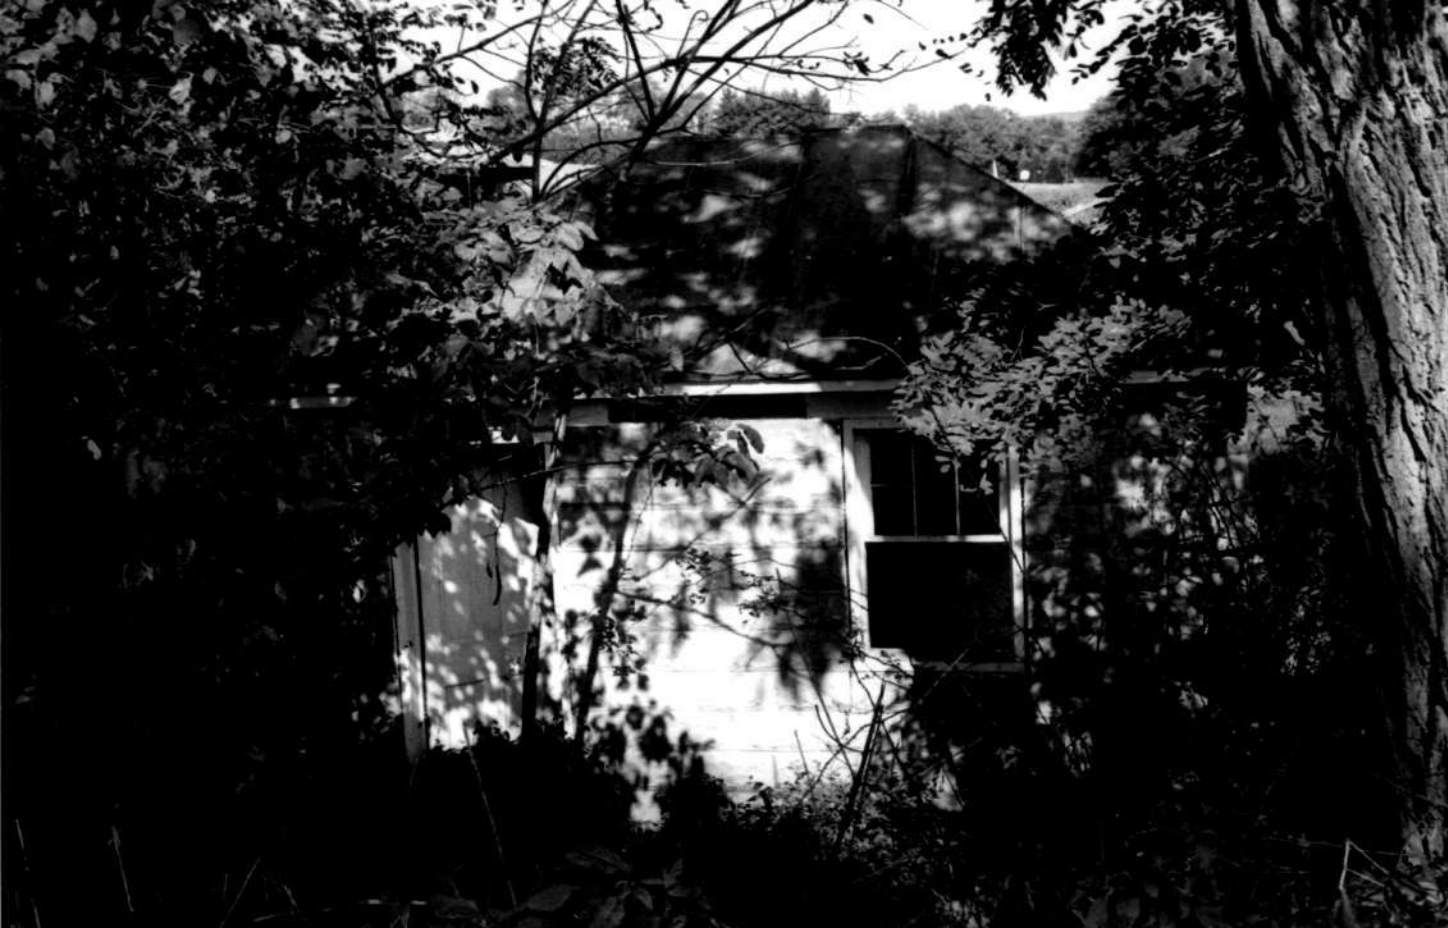
4/9

Springhouse - front (east) elevation

An early twentieth-century springhouse is located northeast of the house. The one-story building faces southeast. The front (southeast) and southwest elevations are constructed of rusticated concrete block. The rear (northwest) and northeast elevations are constructed of plain concrete block. The northeast wall of the springhouse has partially collapsed. The hipped roof is sheathed in standing-seam metal and has boxed eaves. The front elevation features an off-center, four-panel wood door. The building has wood-frame, six-over-six-light, double-hung sash windows. Wood lintels adorn the door and window openings. Poured-concrete stairs are located along the southwest elevation of the springhouse. A half-underground structure with a flat poured-concrete roof and an opening on the northeast side is located southwest of the stairs. The springhouse is in poor condition.

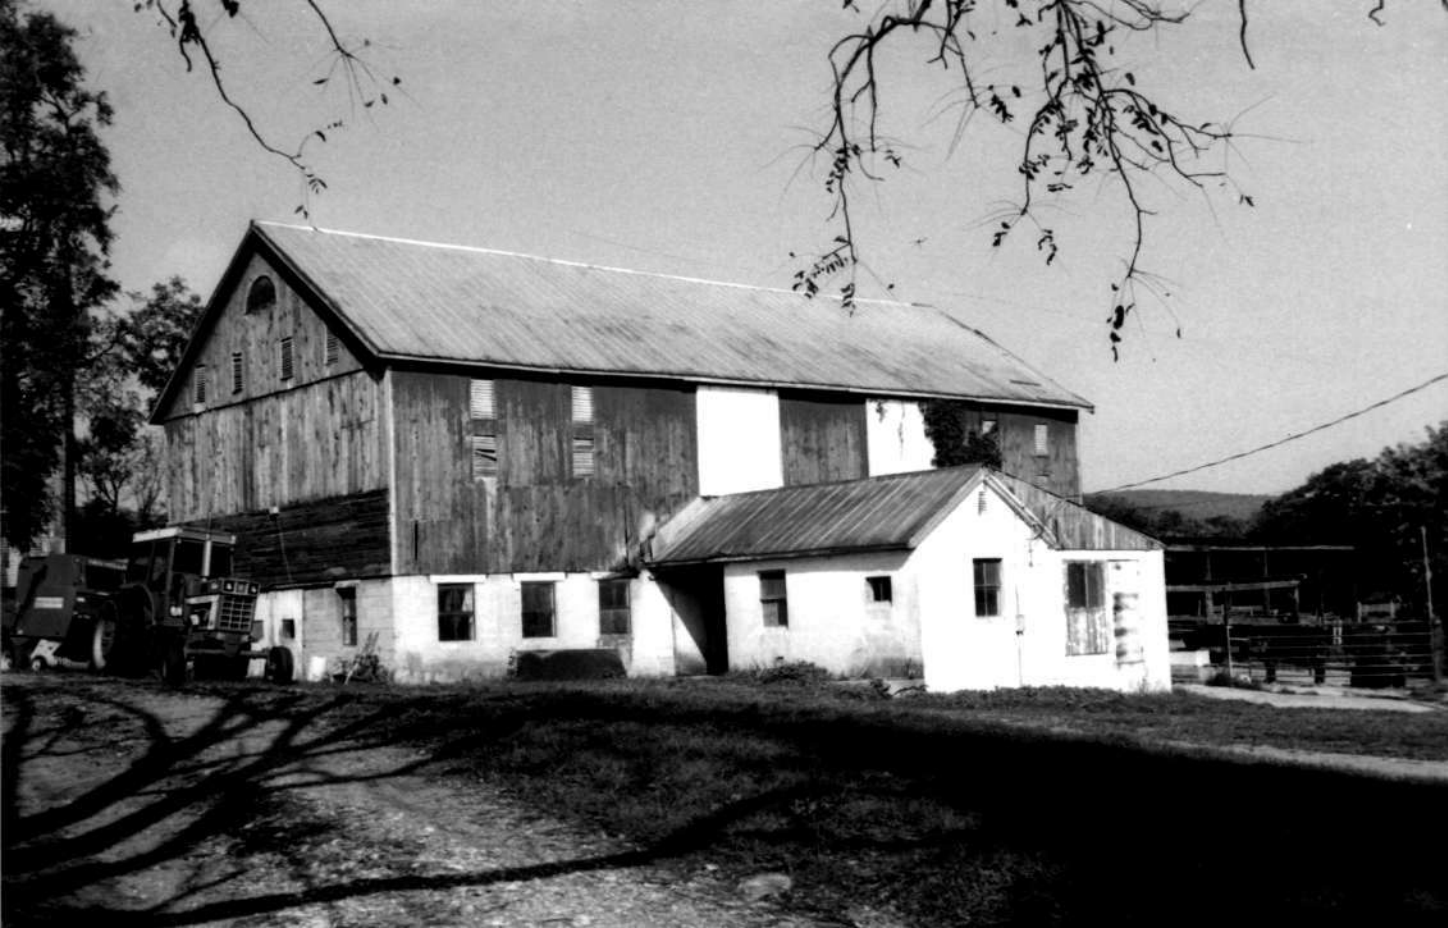
5/9

Bank barn, dairy, and loafing shed - SE corner;  
Animal shed - E. elevation (north of barn)

A complex of agricultural buildings and structures is located west of the house. The early twentieth-century, wood-frame, gable-roof bank barn rests on a concrete-block foundation. A partial stone foundation is visible at the northwest corner, suggesting that the current barn was built on a former foundation. Metal-frame, four-light, fixed-sash windows with wood lintels are located in the foundation walls. Vertical-board, sliding track paired doors are centered on the foundation of the south gable elevation. The barn's exterior walls are clad with a combination of vertical wood siding, horizontal wood

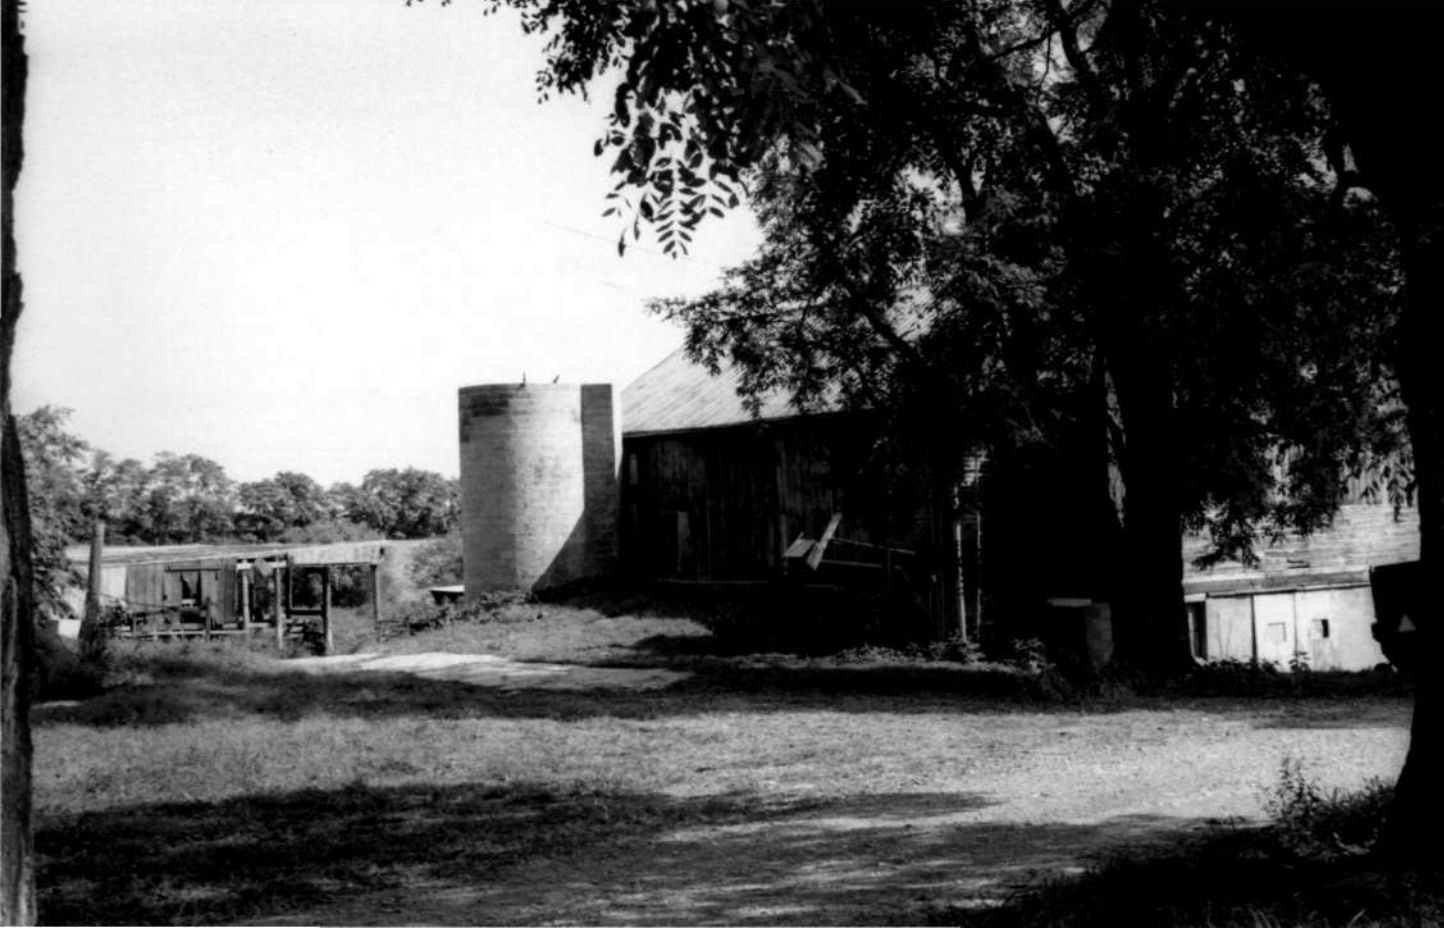
6/9

Animal shed - S. elevation (north of barn)

A mid-twentieth century animal shed is located northwest of the bank barn. The wood-frame, shed-roof building faces east. The animal shed rests on a concrete-block foundation and has a poured-concrete floor. Exterior walls are clad with standing-seam metal. The front (east) elevation remains open. Roof framing is circular sawn. The roof is supported by telephone poles and is sheathed in standing-seam metal. Circular-sawn wood animal stalls are present inside the building. A shed-roof addition, which appears to have previously contained animal stalls, is located on the north elevation. The animal shed is in fair condition.

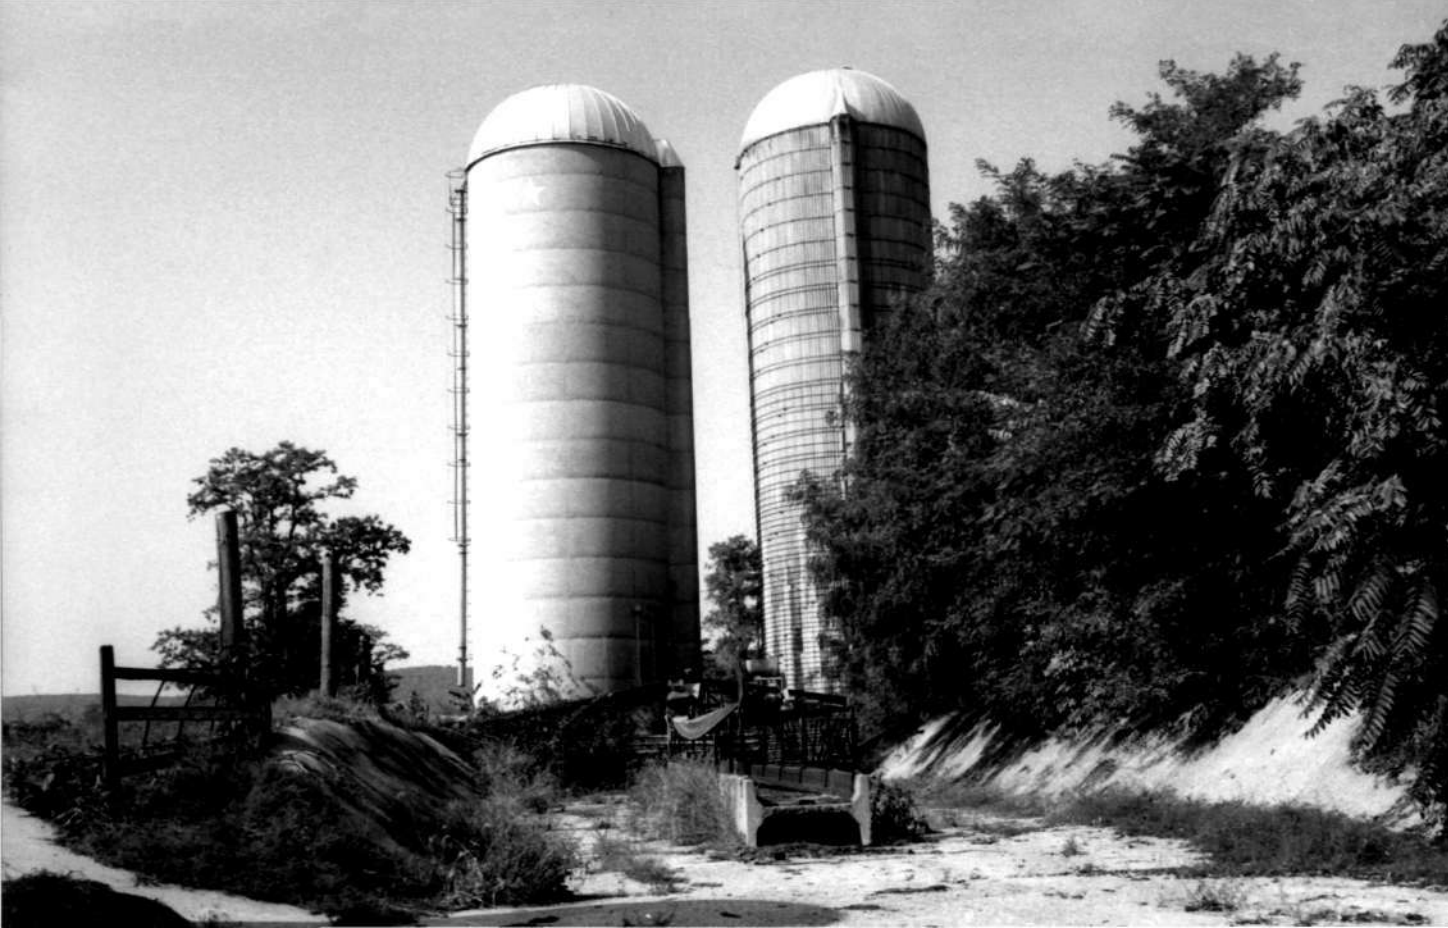
1/9

Large concrete silos - view west

Two large, concrete silos with metal domes are located west of the bank barn. The north silo features circular steel bands and appears to date to the mid-twentieth century. The south silo was probably constructed mid-to-late twentieth century. A poured-concrete trough with a metal conveyor system is located east of the two silos. The trough lies in a depression that features poured-concrete walls and floor. The silos are in good condition.

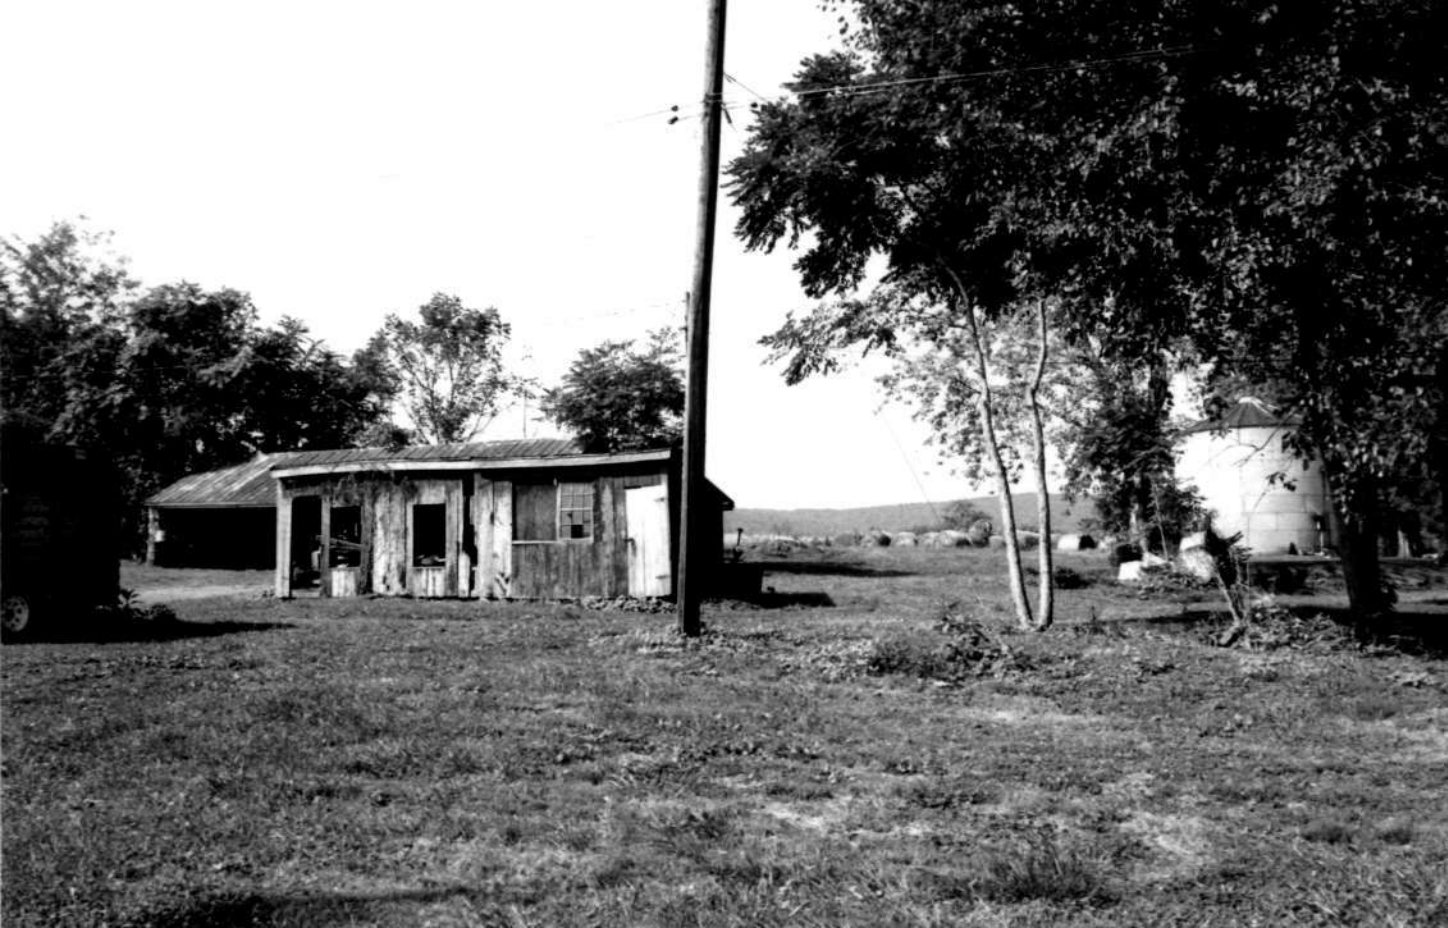
8/9

Workshop - front (east) elevation; Small equipment  
shed - front (east) elevation (behind workshop);  
Large metal grain bin - view west

A large, cylindrical, metal grain bin is located south of the bank barn. The mid-to-late twentieth century bin rests on a concrete platform and features a conical roof sheathed in standing-seam metal. The grain bin is in fair condition.

A small equipment shed is located southwest of the workshop. The mid-twentieth century shed faces east and is constructed of concrete block. The shed has a dirt floor. The gable roof is sheathed in standing-seam metal. The front (east) elevation remains open, and telephone poles support the roof. The shed is in fair condition.

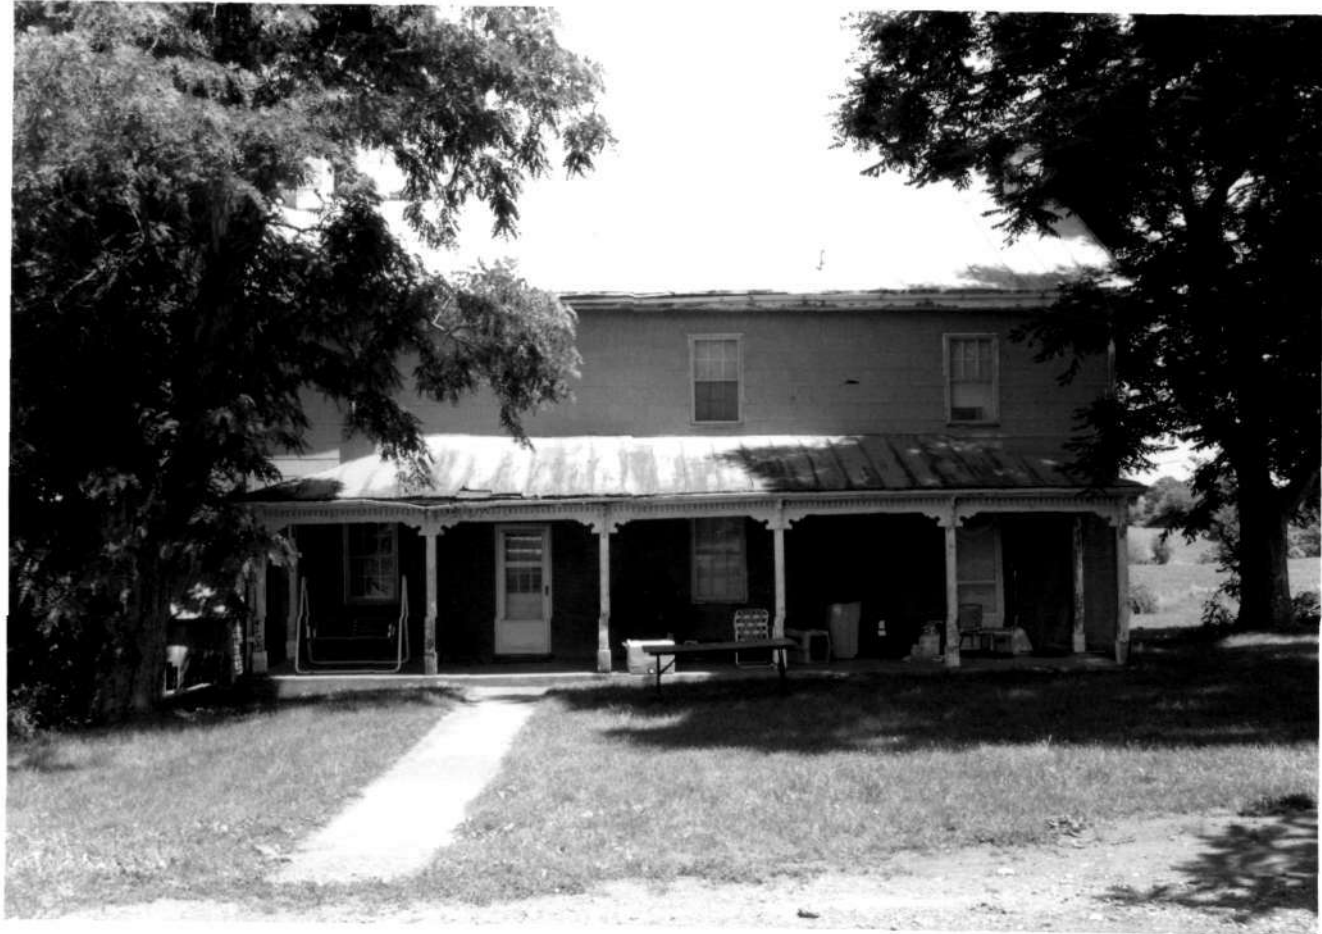
2/21

Farmhouse - front (W) elevation

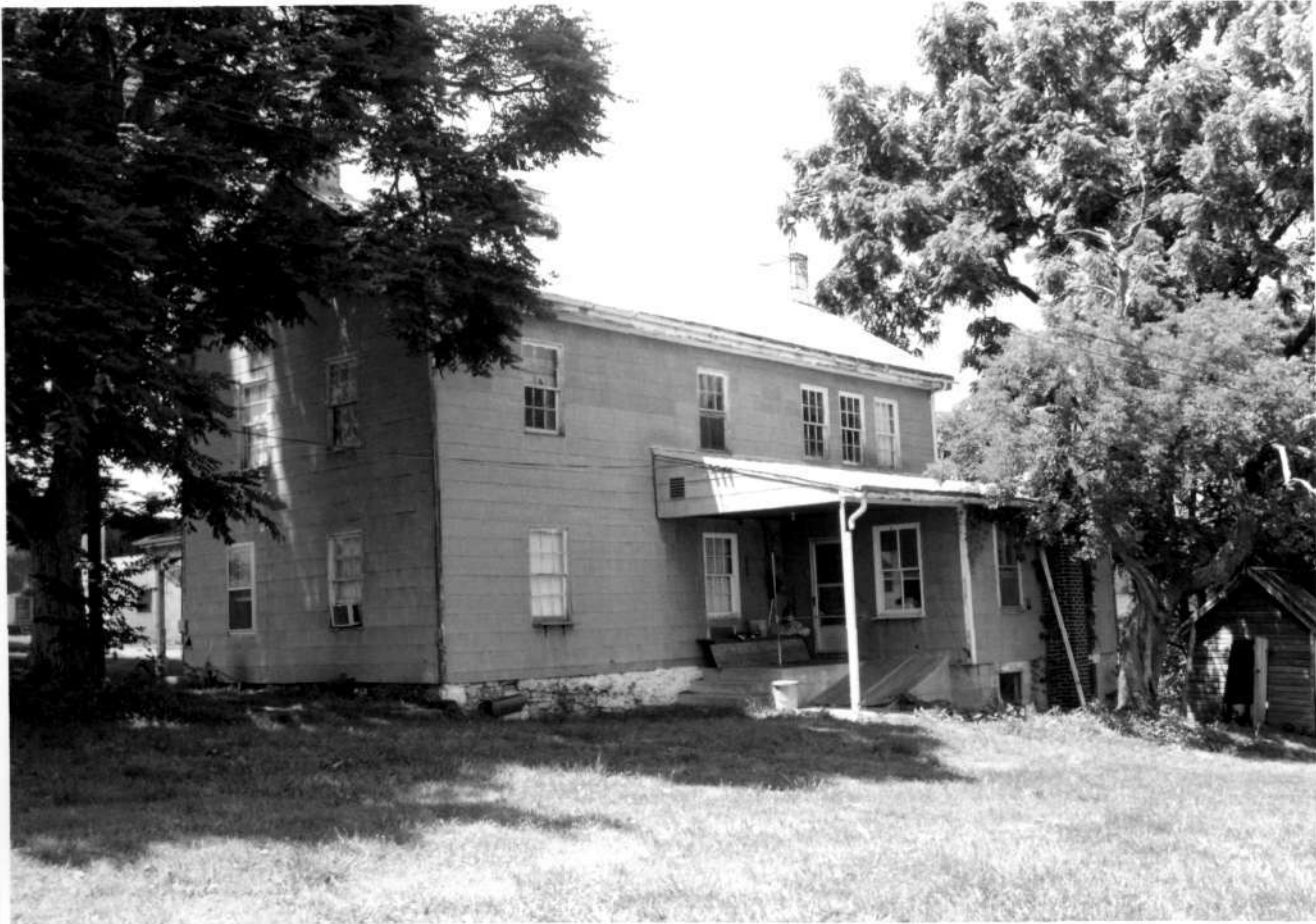
3/21

Farmhouse- SE corner

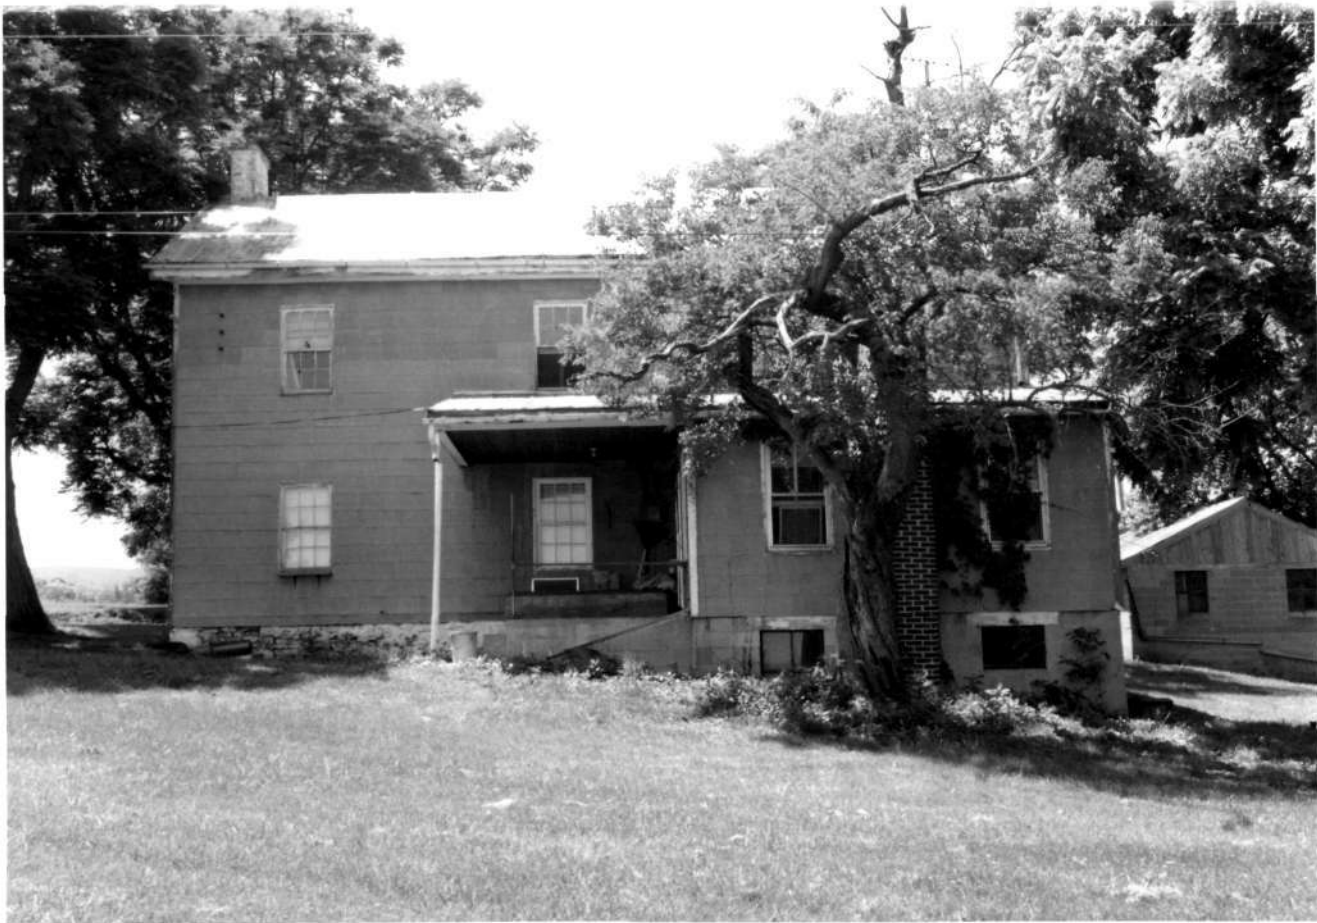
4/21

Farmhouse - rear (E) elevation

The rear elevation of the main block features four windows in the south section--two on the first story and two on the second story. The original (north) section has three windows on the second story; the one-story, shed-roof addition projects from the first story. The addition rests on a concrete-block foundation and contains wood-frame, two-over-two-light, double-hung sash windows. An exterior brick chimney is located on the rear elevation of the addition; the chimney rises between two windows. The south elevation of the addition contains a half-glass wood door, a window, and a bulkhead basement door. The north elevation of the addition features a window with a basement entrance beneath.

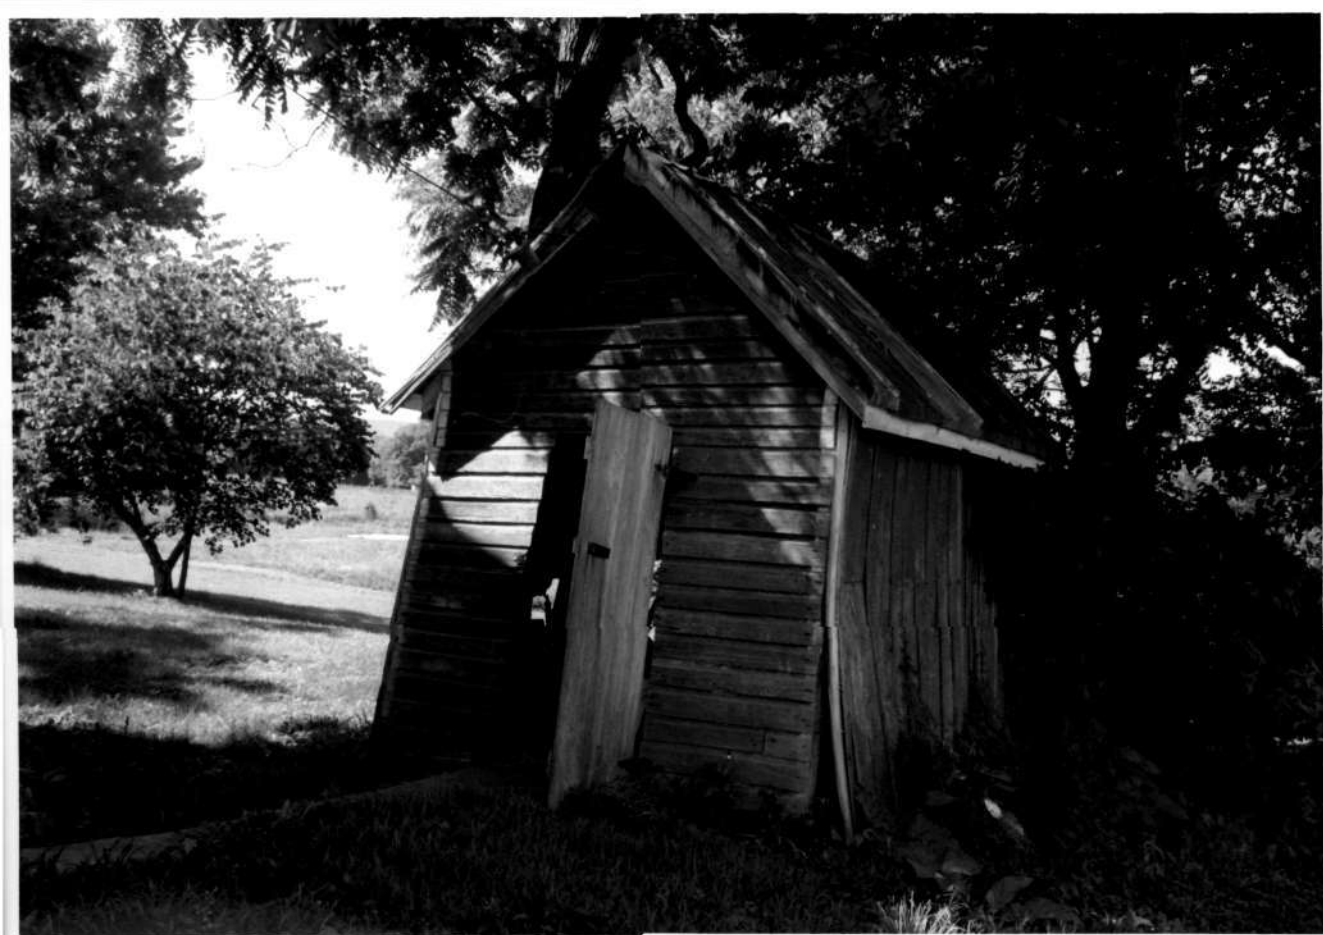
9/21

Small shed - SE corner

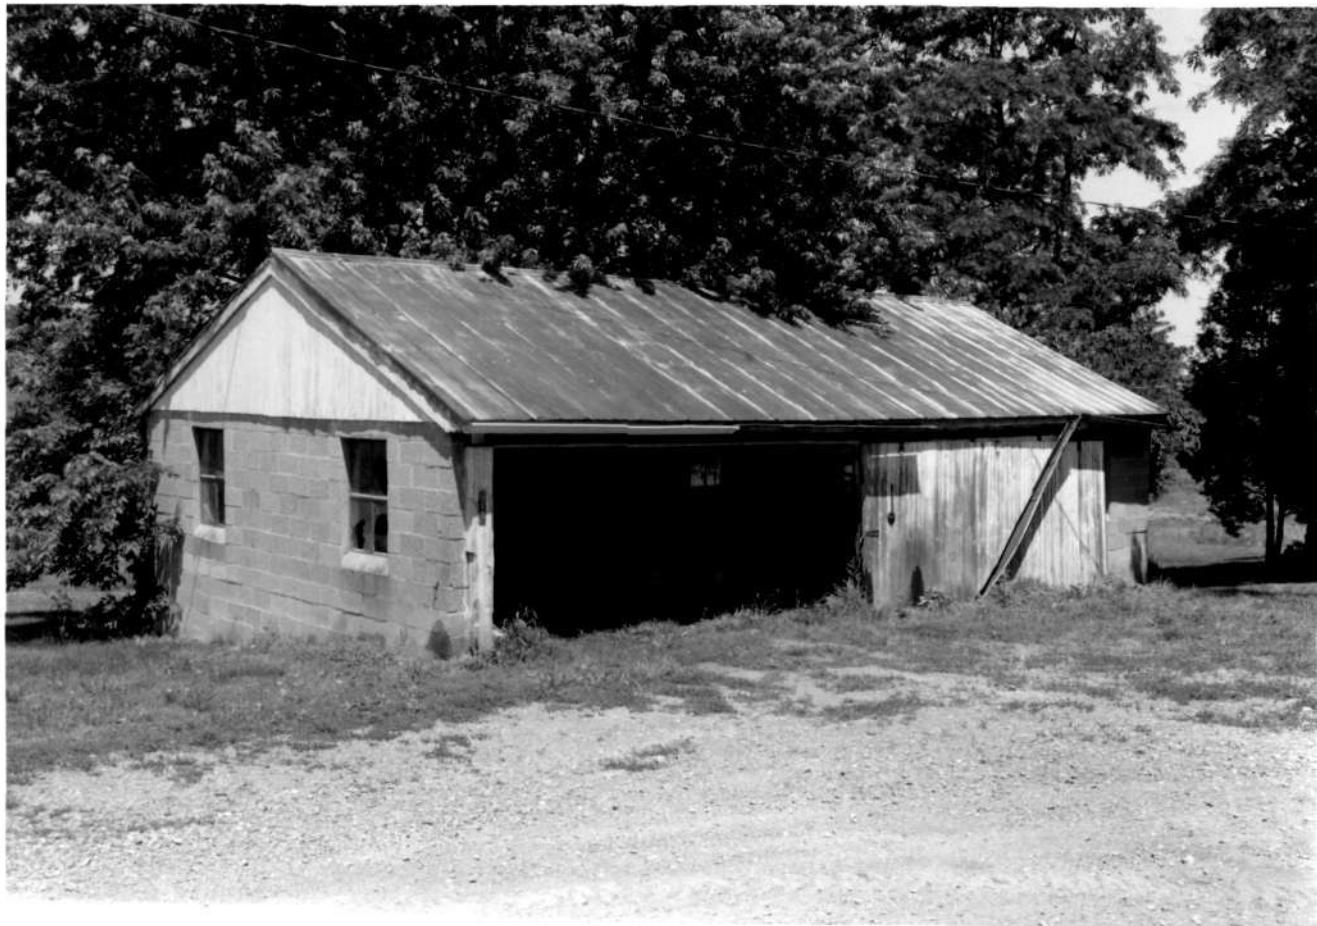
10/21

Garage - SW corner

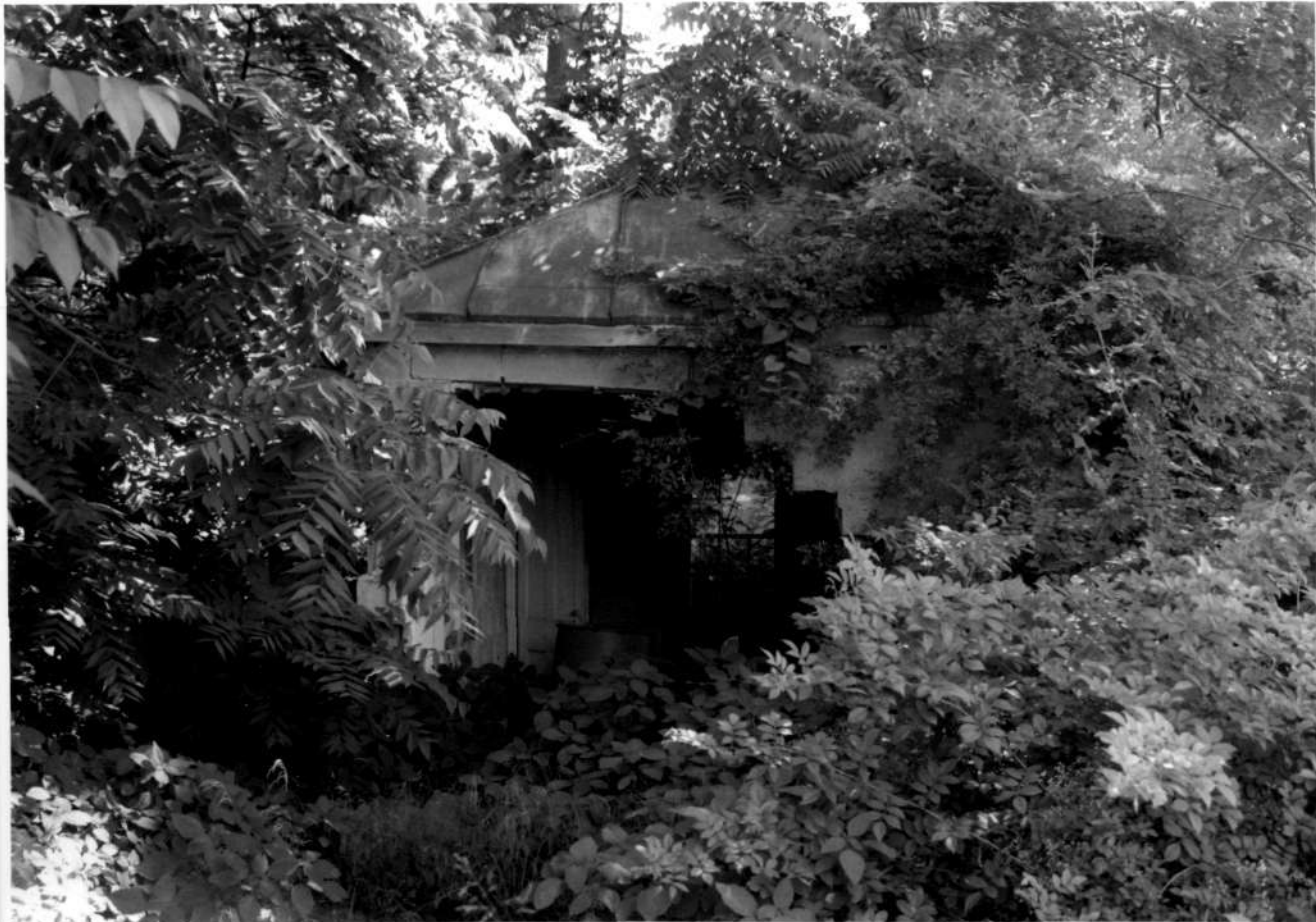
11/21

Springhouse - N corner

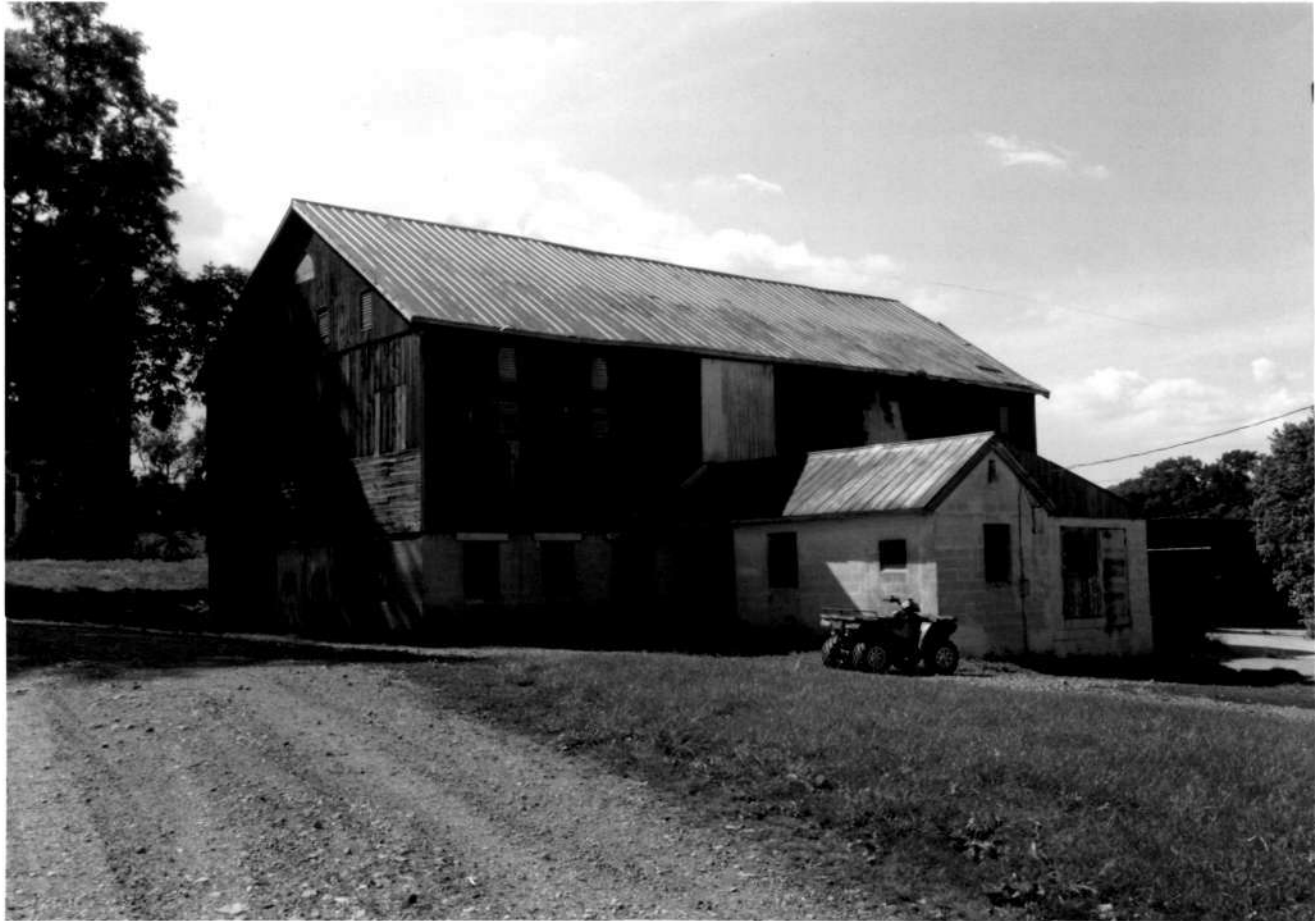
12/21

Bank barn + dairy - SE corner

The barn's interior accommodates a milking parlor on the lower level. The main story of the barn has a four-bay interior arrangement, with two central threshing floors flanked by hay mows; the floor is composed of wide, circular-sawn, random-width boards. The barn features H-bent construction with king-post trusses on the gable ends and a sawn common-rafter roof. Framing members, most of which are sawn, feature mortise-and-tenon joints with tree nails. Some hewn lumber appears to have been re-used from a former building. The barn is in fair condition.

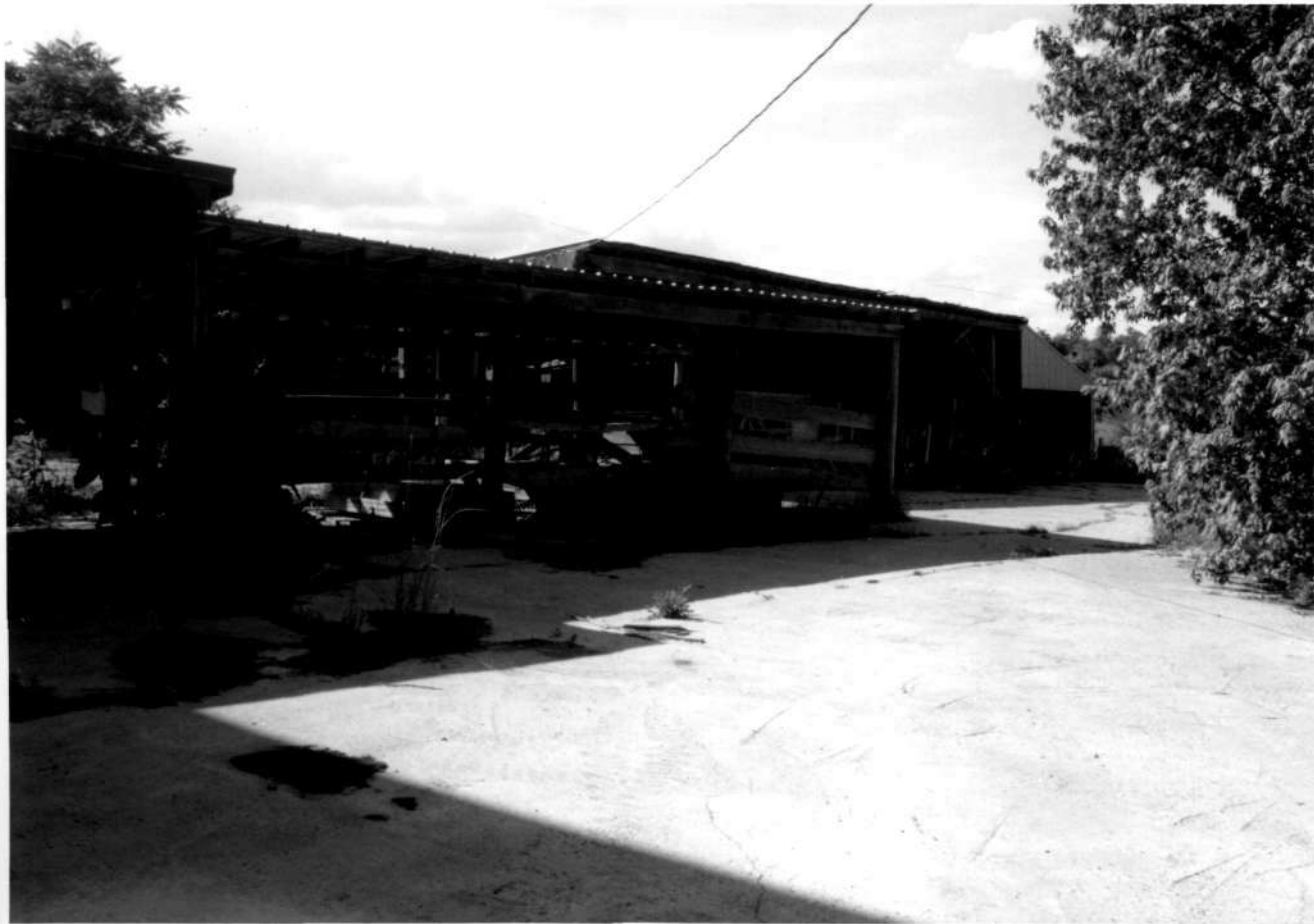
15/21

Loafing shed + animal shed - E elevations
